**CALSPAN ON-SITE AIR BAG/ARM FRACTURE  
CRASH INVESTIGATION**

**CALSPAN CASE NO. 94-42**

**VEHICLE #1 - 1991 DODGE SPIRIT**

**VEHICLE #2 - 1985 FORD TEMPO GL**

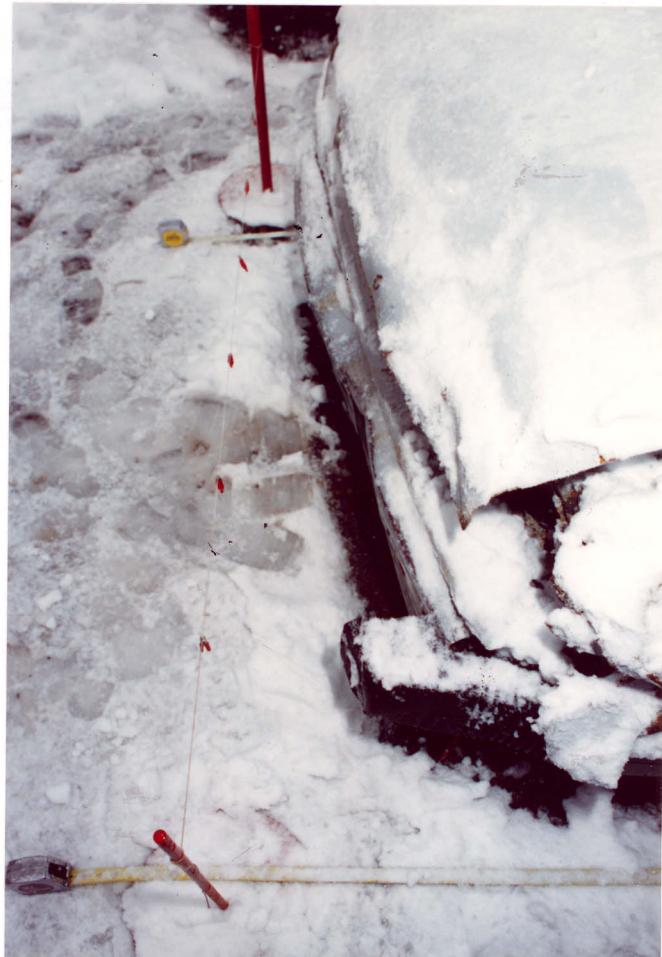
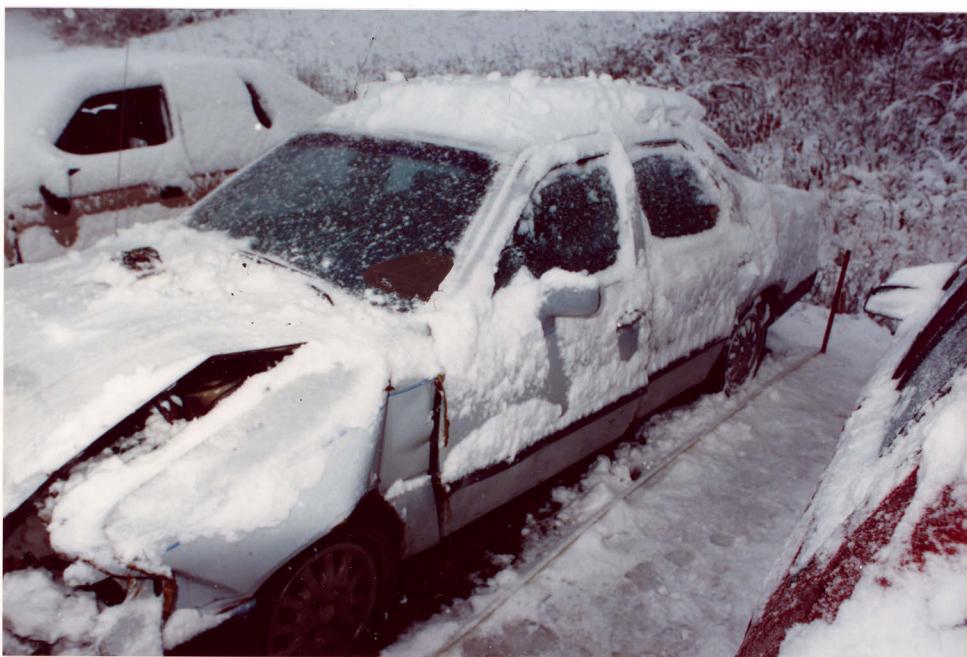
62. Lateral view of the frontal plane showing the rearward displacement of the front bumper.

63. Overhead view of the frontal plane illustrating the crush profile.

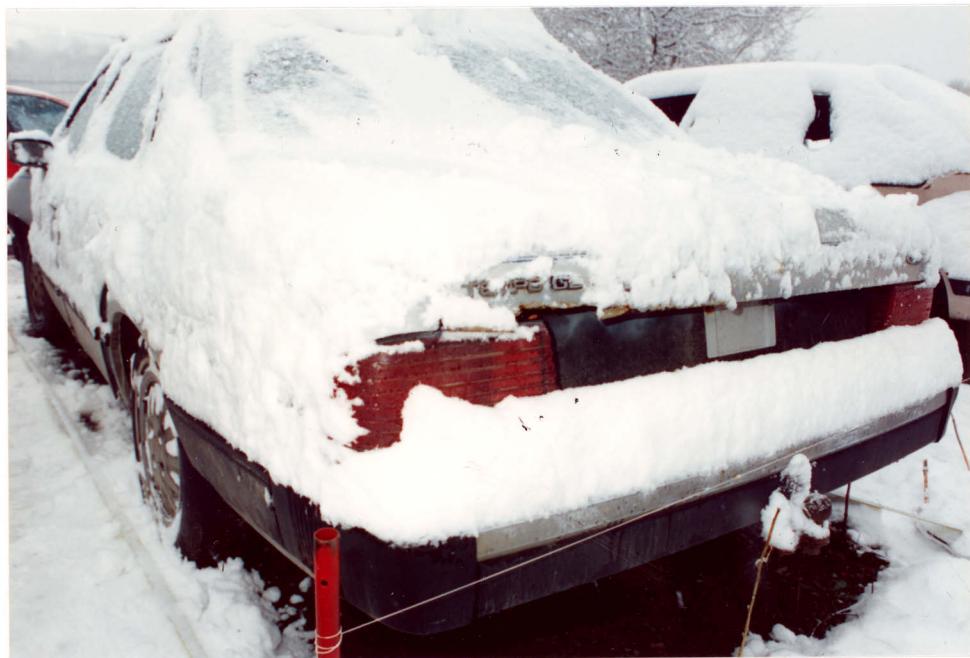
65. View of the left rear corner of Vehicle #2.

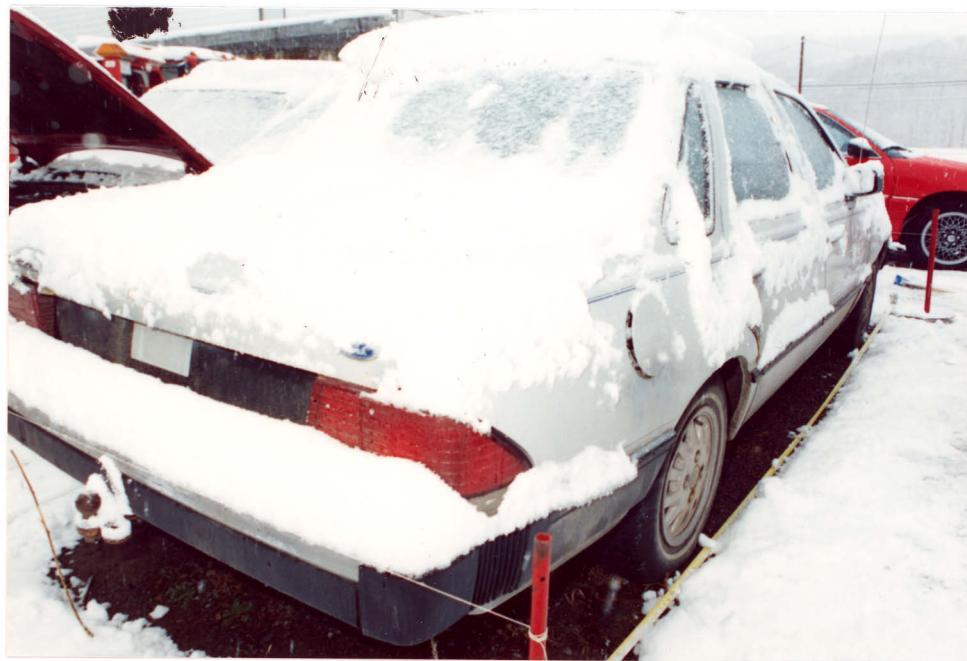
66. View of the right rear corner.

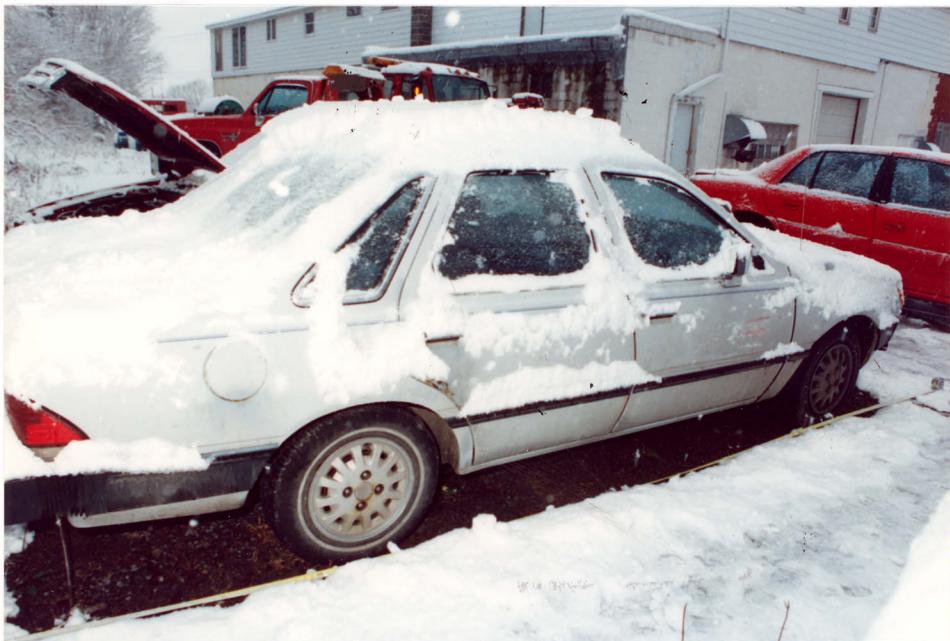
67. View of Vehicle #2's right side plane.

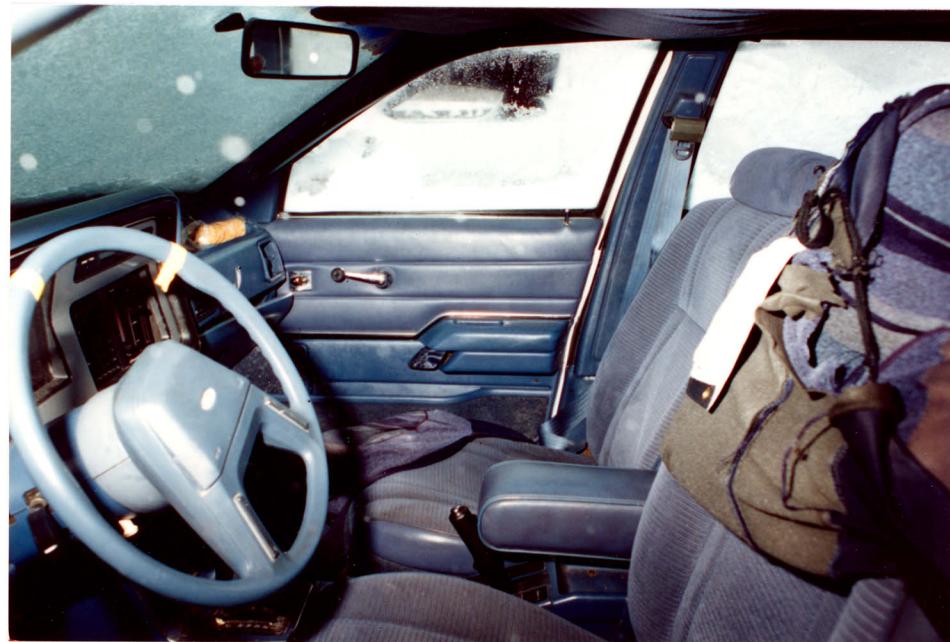
70. Lateral view of the front seating area.

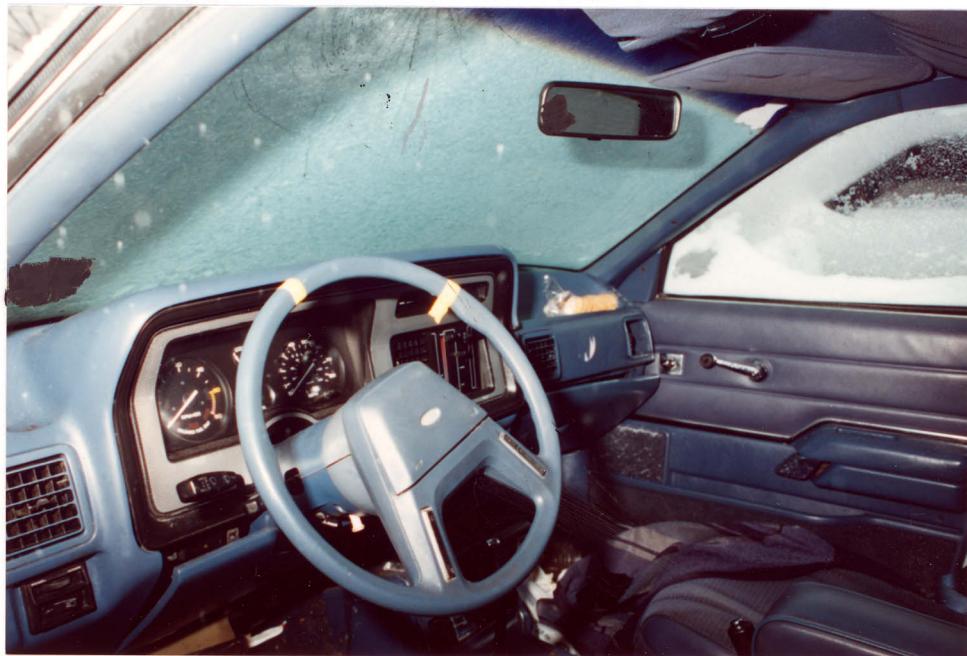
71. Angular view of Vehicle #2's instrument panel taken from the left side of the vehicle.

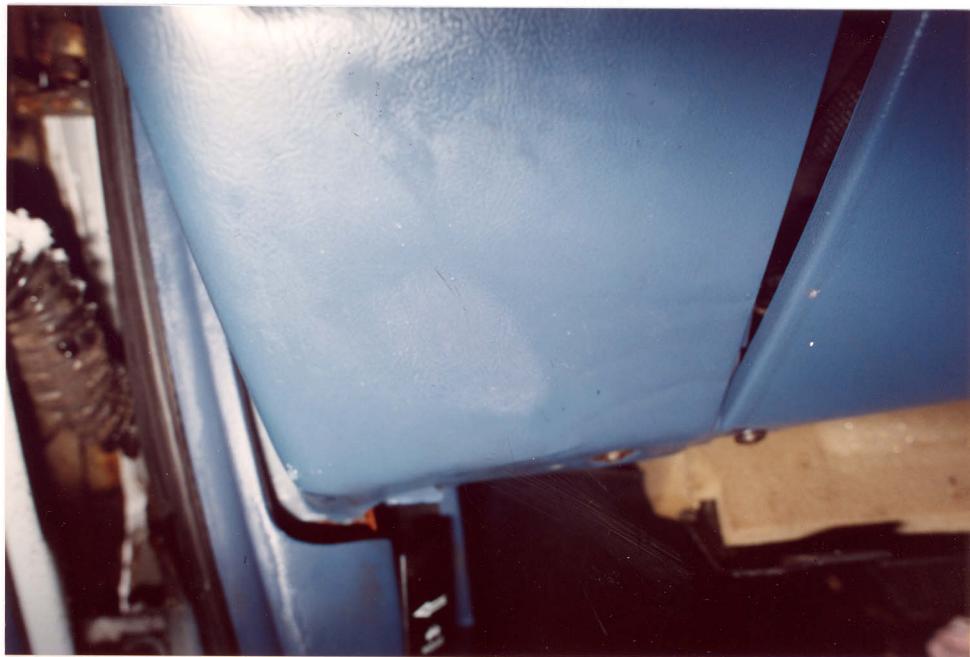
72. View of the lower instrument panel showing a scuff mark below the headlight switch from the driver's left knee.

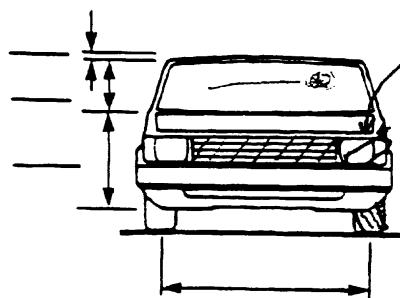
Left front air bag impact sensor located 40.6 cm (16.0") left of the front engine side of the vertical headlight mounting bracket

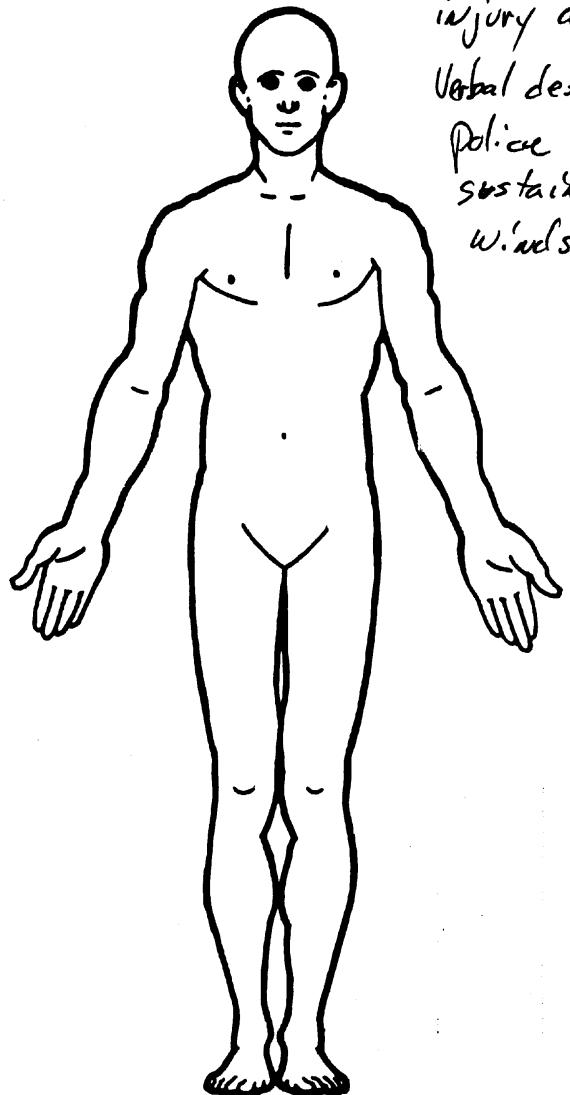
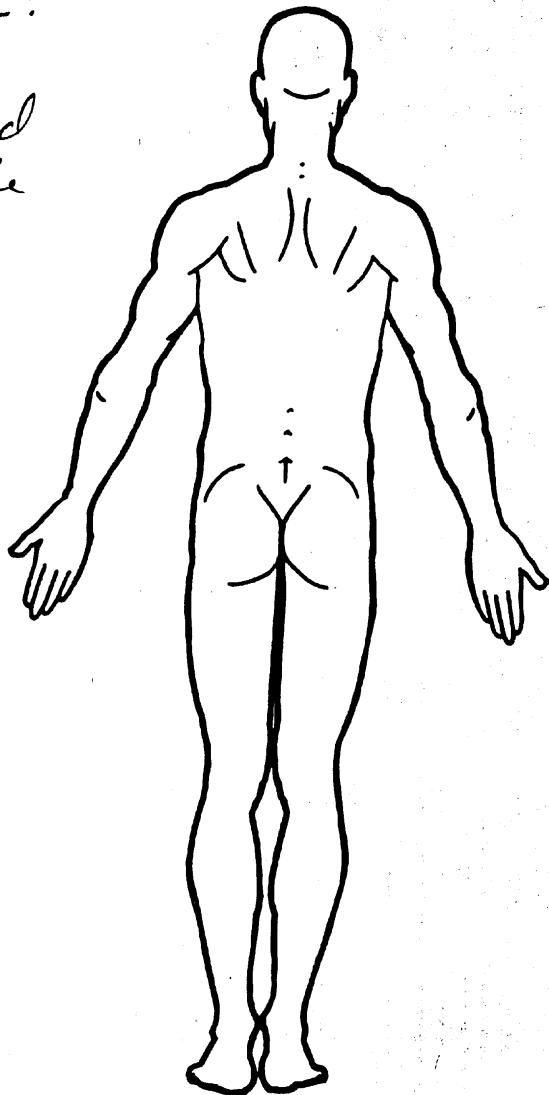
Police Report listed  
injury as a concussion.  
Verbal description by the  
police indicated forehead  
sustained cuts from the  
windshield contact

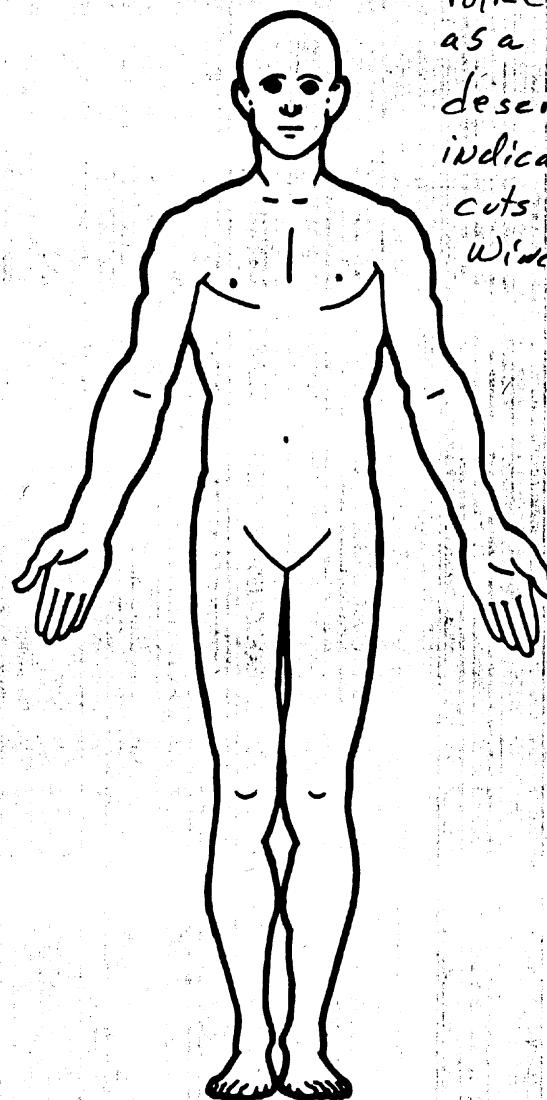
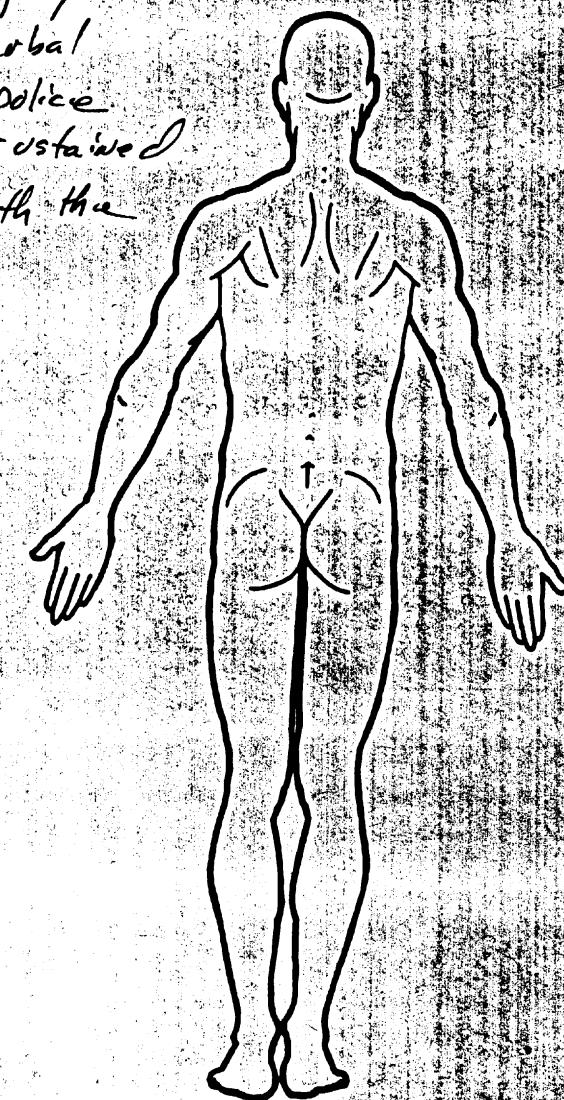
Police report listed injury  
as a concussion. Verbal  
description by the police  
indicated forehead sustained  
cuts from contact with the  
windshield.
